# Gate Valve with Hard Rubber Lining

## An Epoch-Making Seawater Resistant Valve

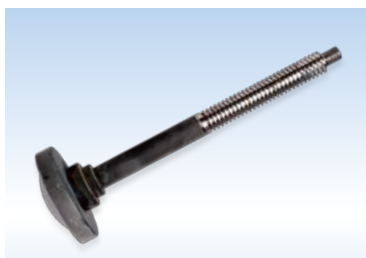
Stem of Globe valve

We succeeded in providing a lining even for a shaft, which had been deemed impossible in the past, by interlocking a disc and a stem in our own unique way. As a result, there is no exposed stainless steel part inside the valve any more, thus eliminating the problem of galvanic battery corrosion that occurs between cast iron and stainless steel.

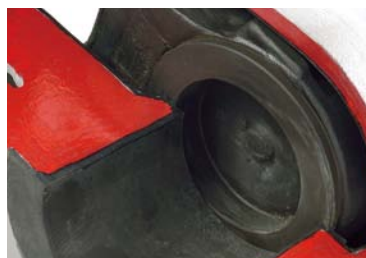
Inside of Gate valve

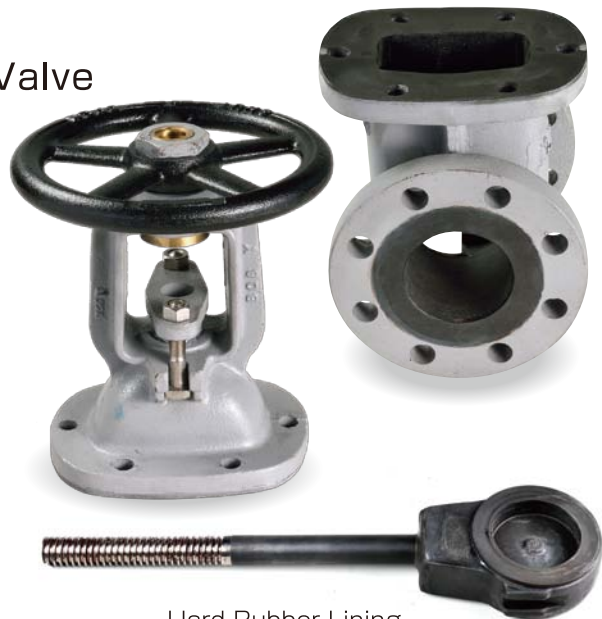
Hard Rubber Lining

Based on the belief that the problem of corrosion in valves can be resolved if we can eliminate the root cause, we finally succeeded in developing a novel method -an innovation to provide a lining for the entire stainless steel surfaces that are subject to corrosion by seawater. That is the valve free from galvanic battery corrosion.

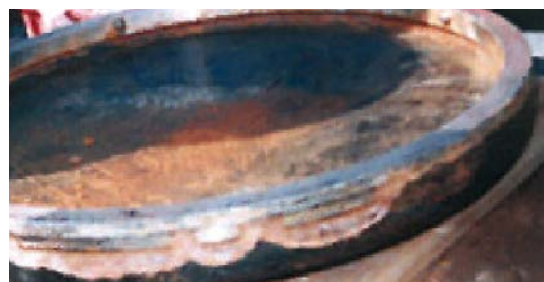
The picture on the right shows the Disc of a swing check valve that has been corroded by seawater. The valving element is made from FC200 and the valve seat is manufactured from SUS304. FC200 is coated with epoxy powder.

The valve made of SUS304 shows no corrosion at all, whereas the valving element of FC200 is simply corroded. Why?

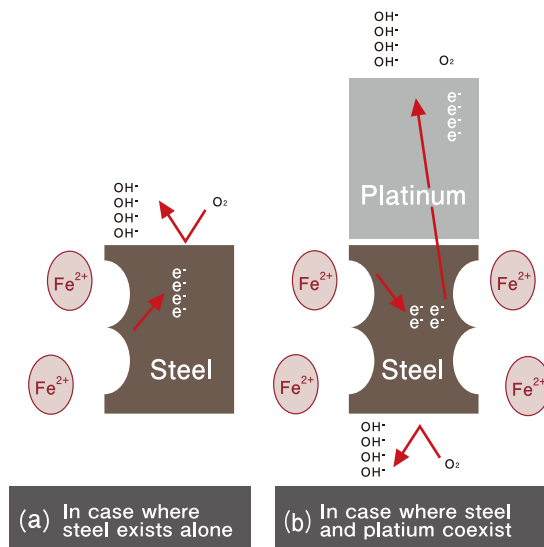
The diagram on the right depicts the mechanism of corrosion that is accelerated when 2 metals of dissimilar electric potentials contact each other. Diagram (a) shows when an oxygen molecule has diffused onto steel, 2 iron atoms dissolve. As shown on diagram (b), however, when another oxygen molecule has diffused onto platinum, 2 more iron atoms dissolve. It means that the rate of corrosion development doubles. This phenomenon is referred to as galvanic corrosion."

It is not enough for protecting base metal that lining and coating on the base metal (for example, tar epoxy coating, tar epoxy resin coating and nylon coating etc) . Valve works so happens potential difference because of breaking away by working and the space between each parts and pinhole etc...

In other words, where there is a galvanic corrosion environment, it allows galvanic corrosion to take place. In addition, what is worse is that the area of stainless steel, noble metal, exposed to seawater is far greater than that of carbon steel, base metal, from which coating or lining peeled off.
