Hard Rubber Lining Valve (Gate, Globe and Swing check)

An Epoch-Making Seawater Resistant Valve

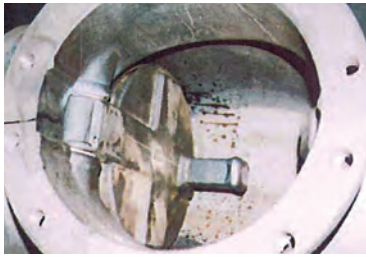
Inside of Swing check valve

We succeeded in providing a lining even for a shaft, which had been deemed impossible in the past, by interlocking a disc and a stem in our own unique way. As a result, there is no exposed stainless steel part inside the valve any more, thus eliminating the problem of galvanic battery corrosion that occurs between cast iron and stainless steel.

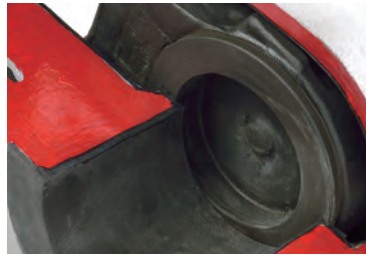
Inside of Gate valve

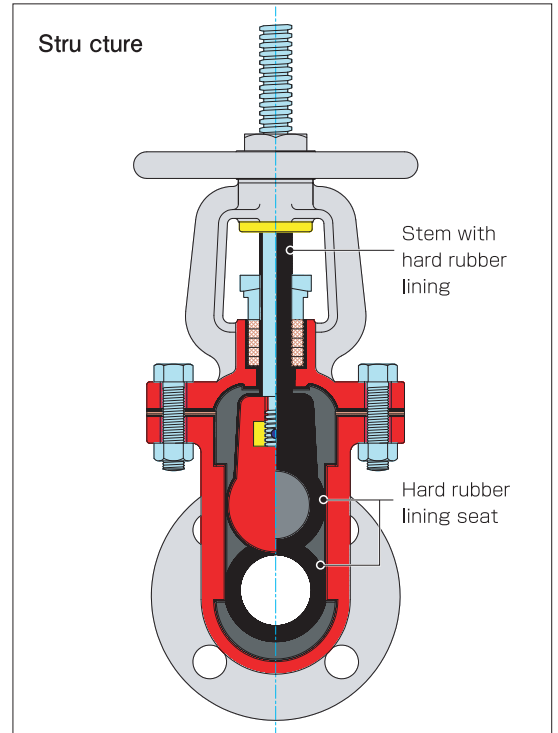
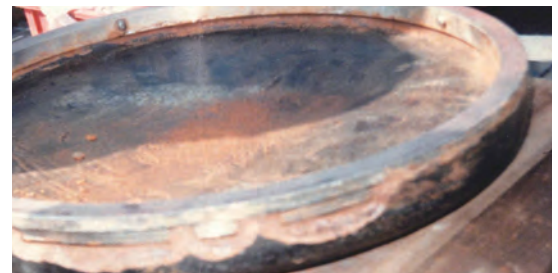
Disc of a swing check valve that has been corroded by seawater

The picture on the right shows the Disc of a swing check valve that has been corroded by seawater. The valving element is made from FC200 and the valve seat is manufactured from SUS304. FC200 is coated with epoxy powder.

The valve made of SUS304 shows no corrosion at all, whereas the valving element of FC200 is simply corroded. Why?

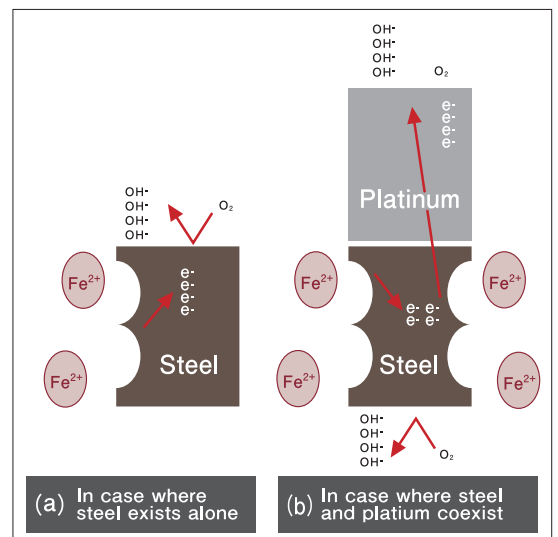
The mechanism of corrosion

The diagram on the right depicts the mechanism of corrosion that is accelerated when 2 metals of dissimilar electric potentials contact each other. Diagram (a) shows when an oxygen molecule has diffused onto steel, 2 iron atoms dissolve. As shown on diagram (b), however, when another oxygen molecule has diffused onto platinum, 2 more iron atoms dissolve. It means that the rate of corrosion development doubles. This phenomenon is referred to as galvanic corrosion."
