## 全面ゴムライニング弁（NSゲート、グローブ、スイング逆止）

### 今までの常識を打破した画期的耐海水用弁

# Hard Rubber Lining Valve (Gate, Globe and Swing check)

## An Epoch-Making Seawater Resistant Valve

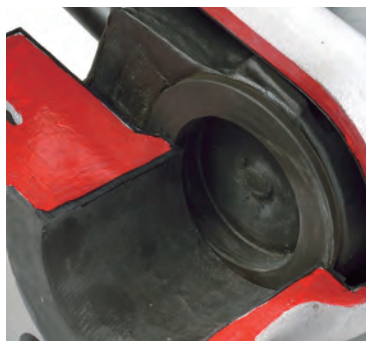
仕切弁の内部

弁体と弁棒を独自の方法で連結することにより、従来不可能とされてきた弁棒にもライニングを施行。弁内部に全くステンレス部品を露出させず铸铁・ステンレス間に生じるガルバニ電池腐蝕を解消。

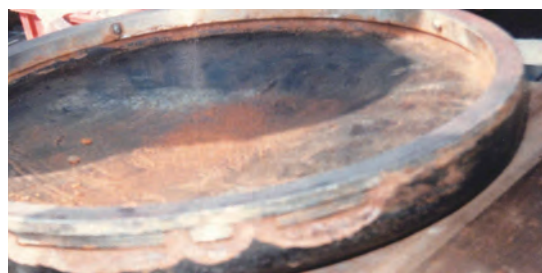
右の写真はスイング逆止弁の弁体（ねじ込み型弁座付き）が海水によって腐蝕されたものです。弁体はFC200、弁座はSUS304です。FC200にはタールエポキシが塗装してあります。弁座のSUS304は全く腐蝕せず、弁体のFC200ばかりが腐蝕しています。なぜでしょうか？

海水によって腐蝕されたスイング逆止弁の弁体

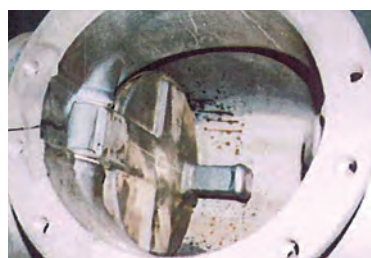
Inside of Swing check valve

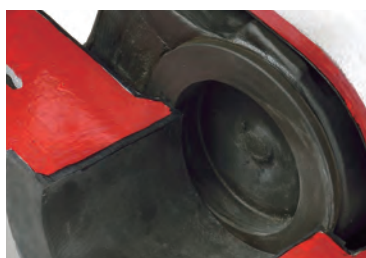
Inside of Gate valve

We succeeded in providing a lining even for a shaft, which had been deemed impossible in the past, by interlocking a disc and a stem in our own unique way. As a result, there is no exposed stainless steel part inside the valve any more, thus eliminating the problem of galvanic battery corrosion that occurs between cast iron and stainless steel.

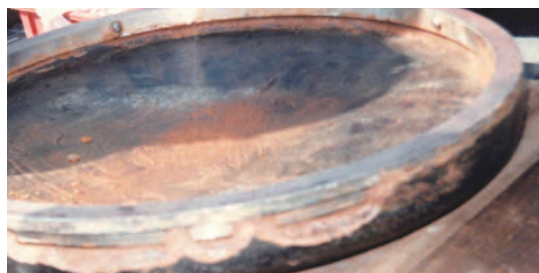
The picture on the right shows the Disc of a swing check valve that has been corroded by seawater. The valving element is made from FC200 and the valve seat is manufactured from SUS304. FC200 is coated with epoxy powder.

The valve made of SUS304 shows no corrosion at all, whereas the valving element of FC200 is simply corroded. Why?

Disc of a swing check valve that has been corroded by seawater
